# Assessment of Road Crossings for Improving Migratory Fish Passage in the Winnicut River Watershed

**Ray Konisky, Director of Marine Science and Conservation  
The Nature Conservancy, New Hampshire Chapter, Concord, NH**

**December 2009**

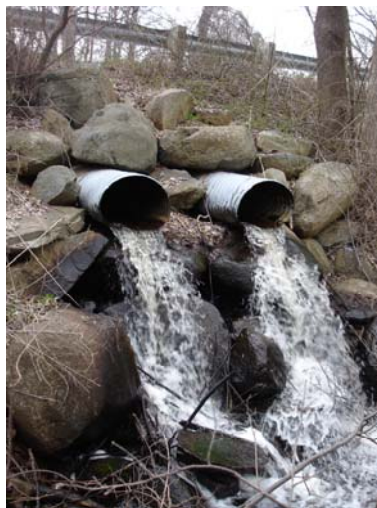
Crossing at Willowbrook Ave, Stratham (R Konisky TNC)

Our spatial analysis showed that many crossings were at or very near terminal points in the stream network. For these crossings, improvements to passage would result in very marginal benefits of increased access to migratory fish spawning and nursery habitat. Those locations with 0.5 miles or less of potential upstream habitat were determined to be low priority for improvements, with sixteen crossings excluded from the priority list (Table 2, ID 3, 4, 8, 9, 13, 14, 15, 16, 17, 18, 21, 26, 29, 37, 39 and 40). It should be noted that crossing 4 (Willowbrook Avenue in Stratham) was the only crossing assessed as a “severe” barrier, but the location of the culvert at the network terminus resulted in a lowered overall priority ranking. A downstream image of crossing 4 is also shown on the Executive Summary page, as it drains a small firepond with twin perched culvert pipes.

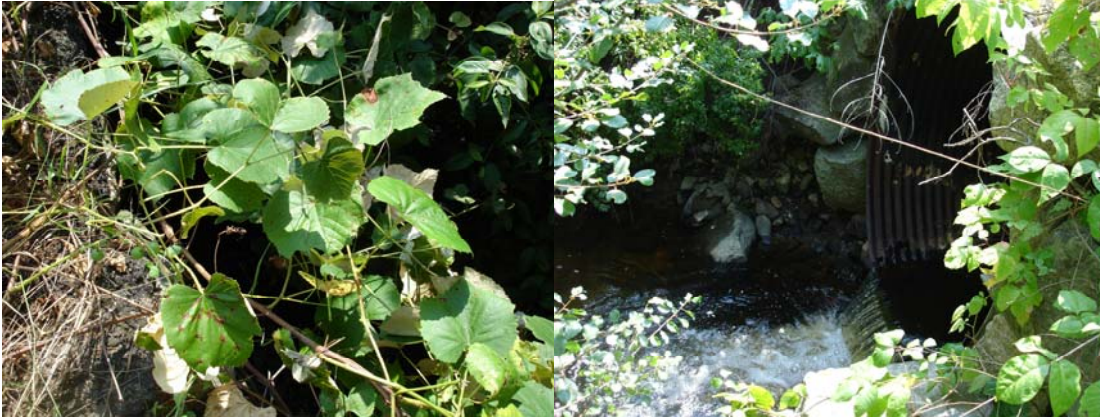
**Crossing 2: Thompson Brook at Winnicut Rd, Greenland**

Notes: Dense vegetation surrounding upstream brook and inlet; slight outlet perch

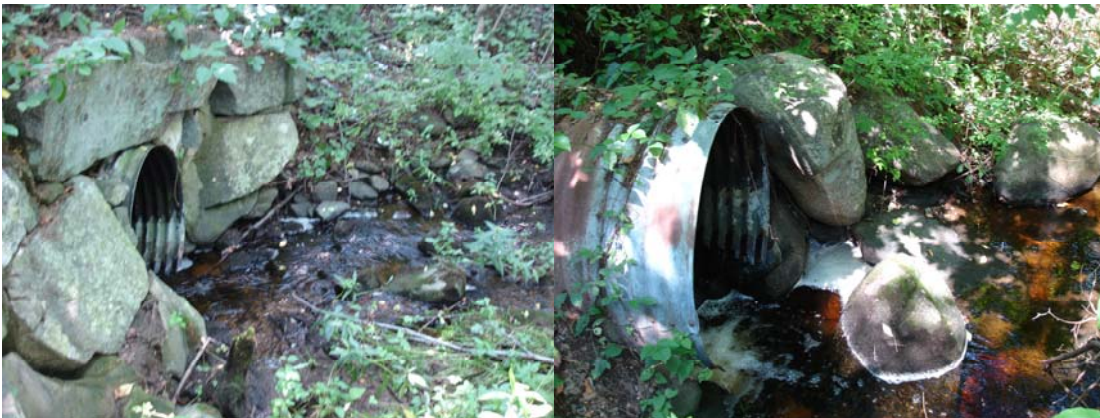
**Crossing 5: Willow Brook at Willowbrook Ave, Greenland**

Notes: Slight outlet perch with two foot section of outlet pipe bottom rusted away

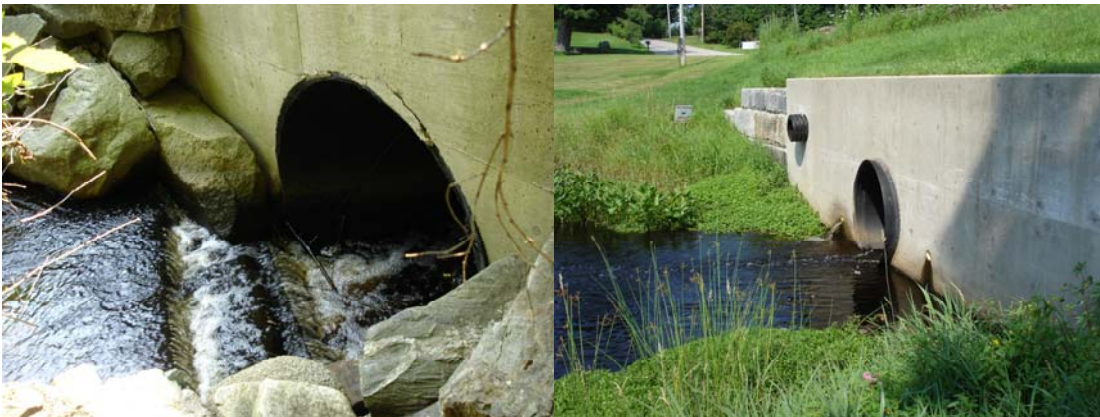
**Crossing 6: Norton Brook at Post Rd, Greenland**

Notes: Terraced inlet drop into large deepwater impoundment downstream of crossing

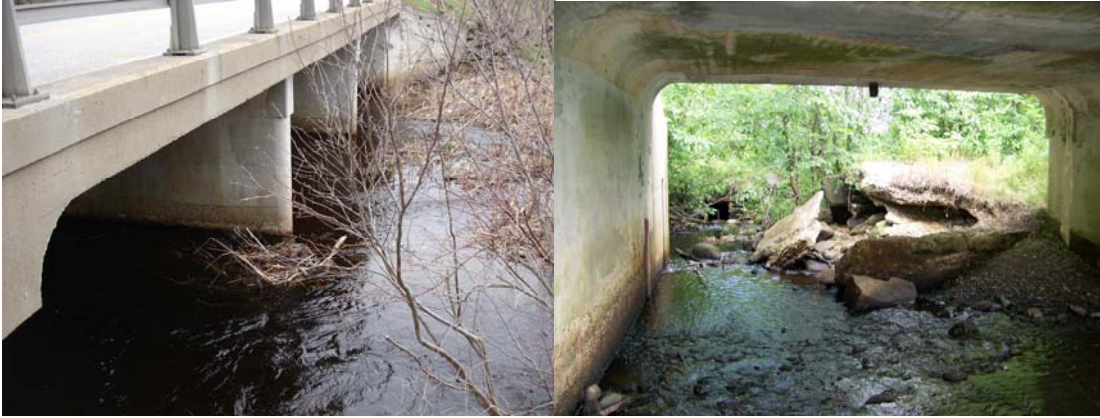
**Crossing 12: Winnicut River at Winnicut Rd, Stratham**

Notes: Three span bridge with multiple downstream impediments associated with old mill structures

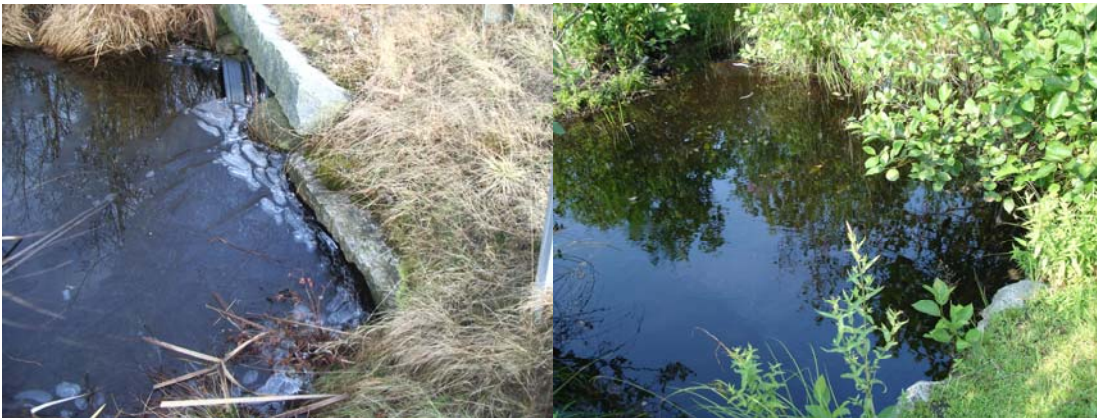
**Crossing 20: Cornelius Brook at Lovering Rd, North Hampton**

Notes: Twin plastic pipes (about 70' apart) near headwaters, signs of removable debris grates at inflow

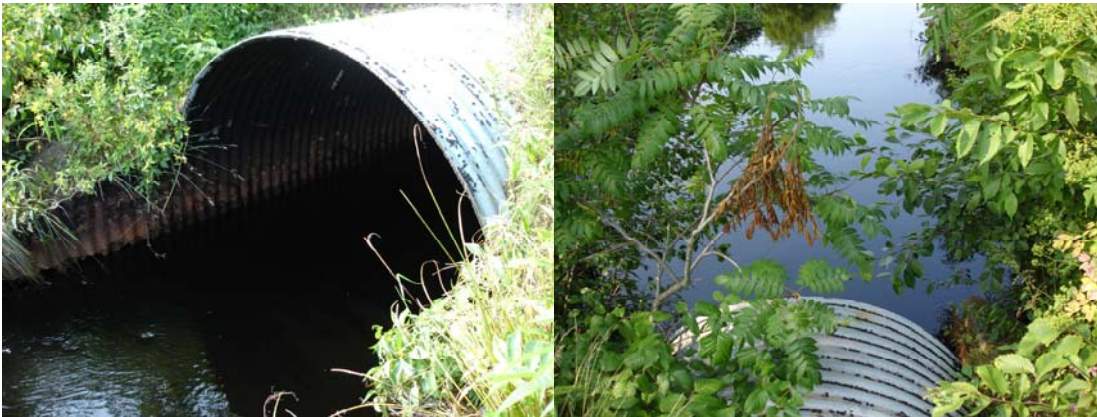
**Crossing 22: Winnicut River at Walnut Ave, North Hampton**

Notes: Near headwaters, slow flowing mainstem with some ponding

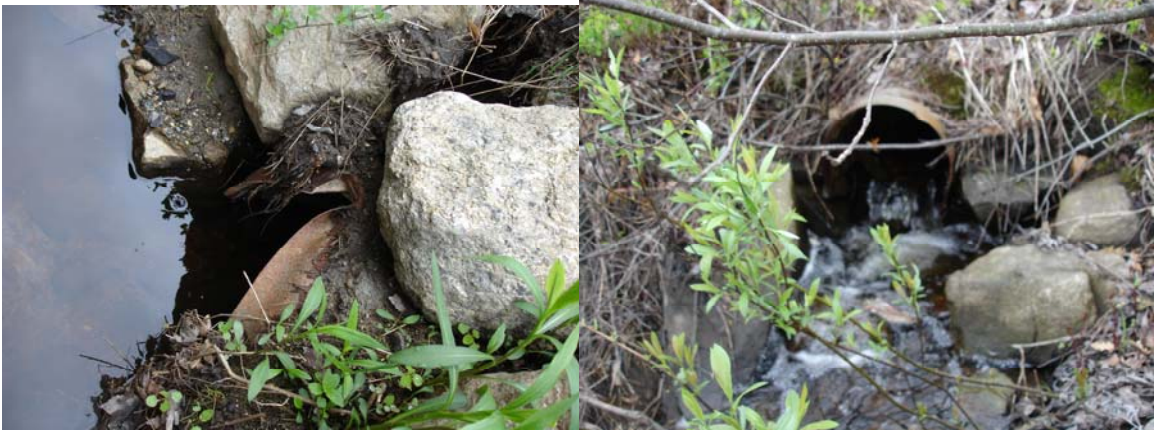
**Crossing 27: Cornelius Brook at North Rd, North Hampton**

Notes: Rusted and corroding culvert pipe with slight outlet perch, flows into golf course

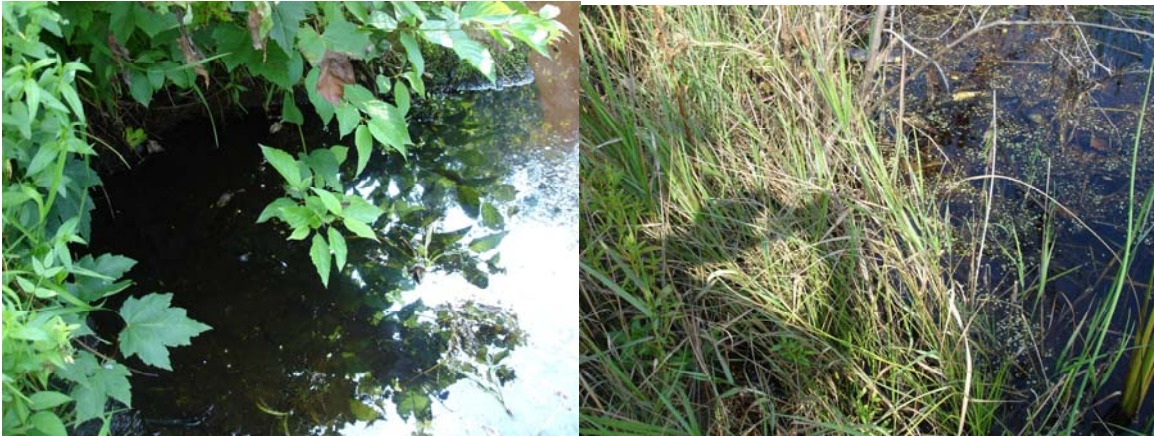
**Crossing 28: Winnicut River at Exeter Rd, North Hampton**

Notes: Dense scrub vegetation upstream and downstream; very slow flows and ponded conditions

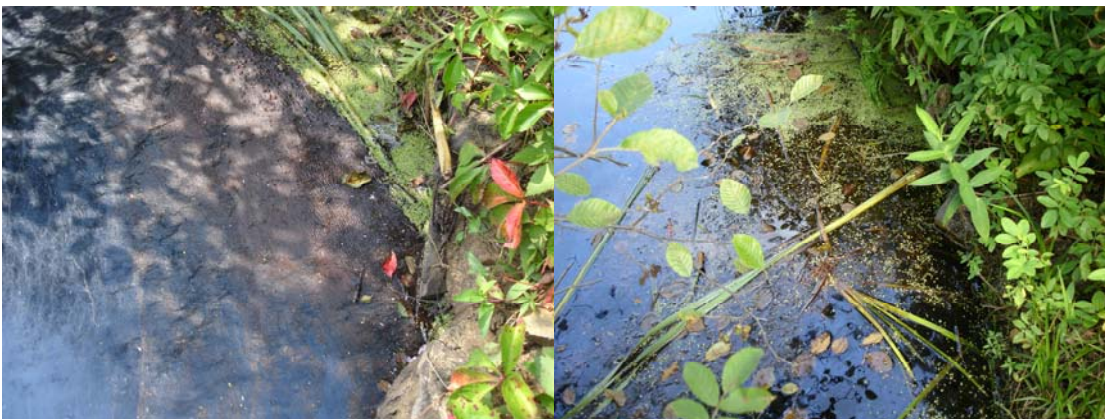
**Crossing 30: Winnicut River at South Rd, North Hampton**

Notes: Dense scrub vegetation upstream and downstream; very slow flows and ponded conditions

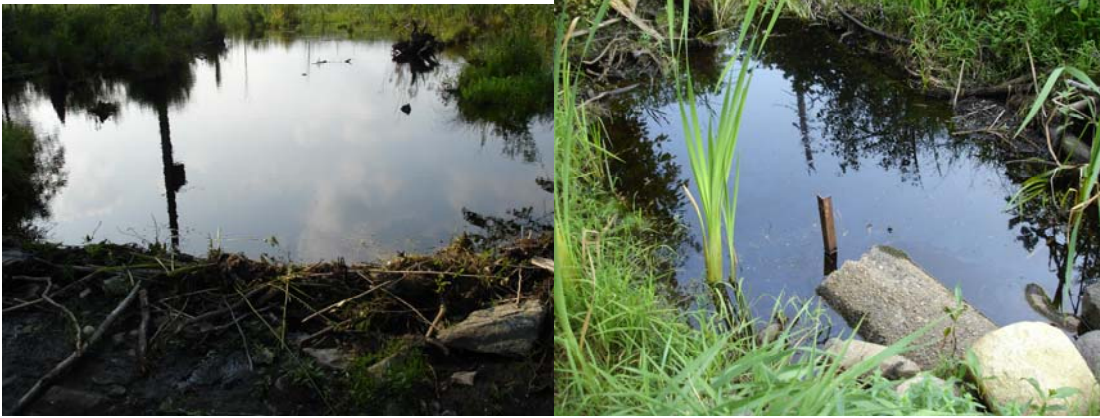
### Crossing 35: Pine Hill Brook at private woods road, North Hampton

Notes: Beaver dam at crossing; impeded flows and eroded concrete pipe

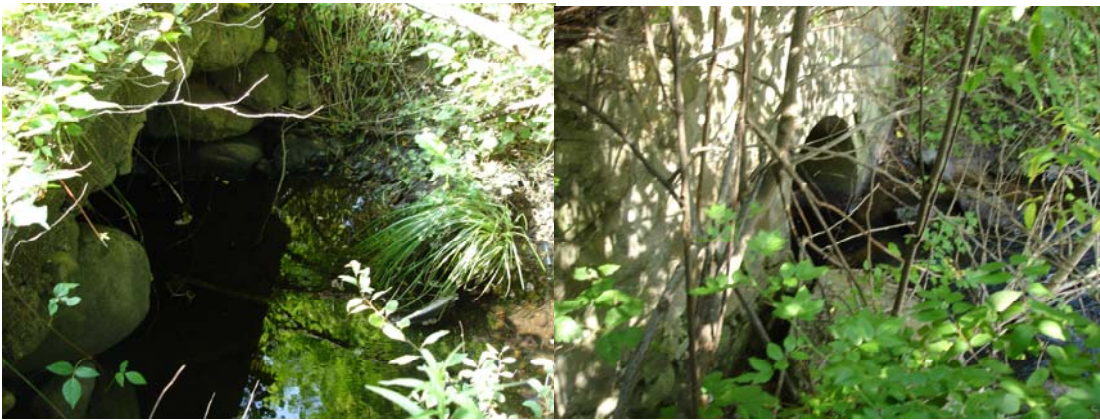
### Crossing 36: Unknown brook at Post Rd, North Hampton

Notes: Dense vegetation upstream and downstream; slow flows and cattail downstream

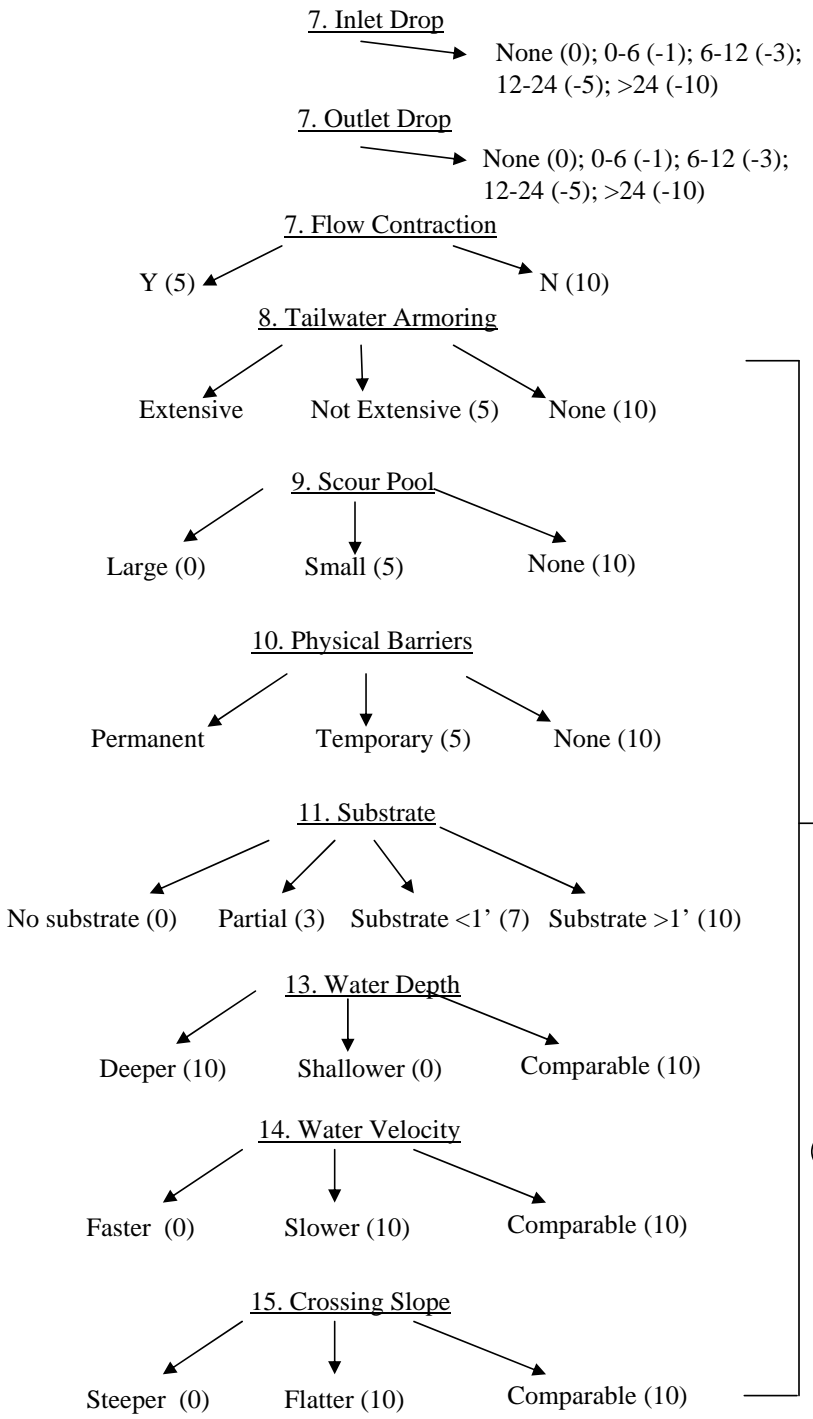
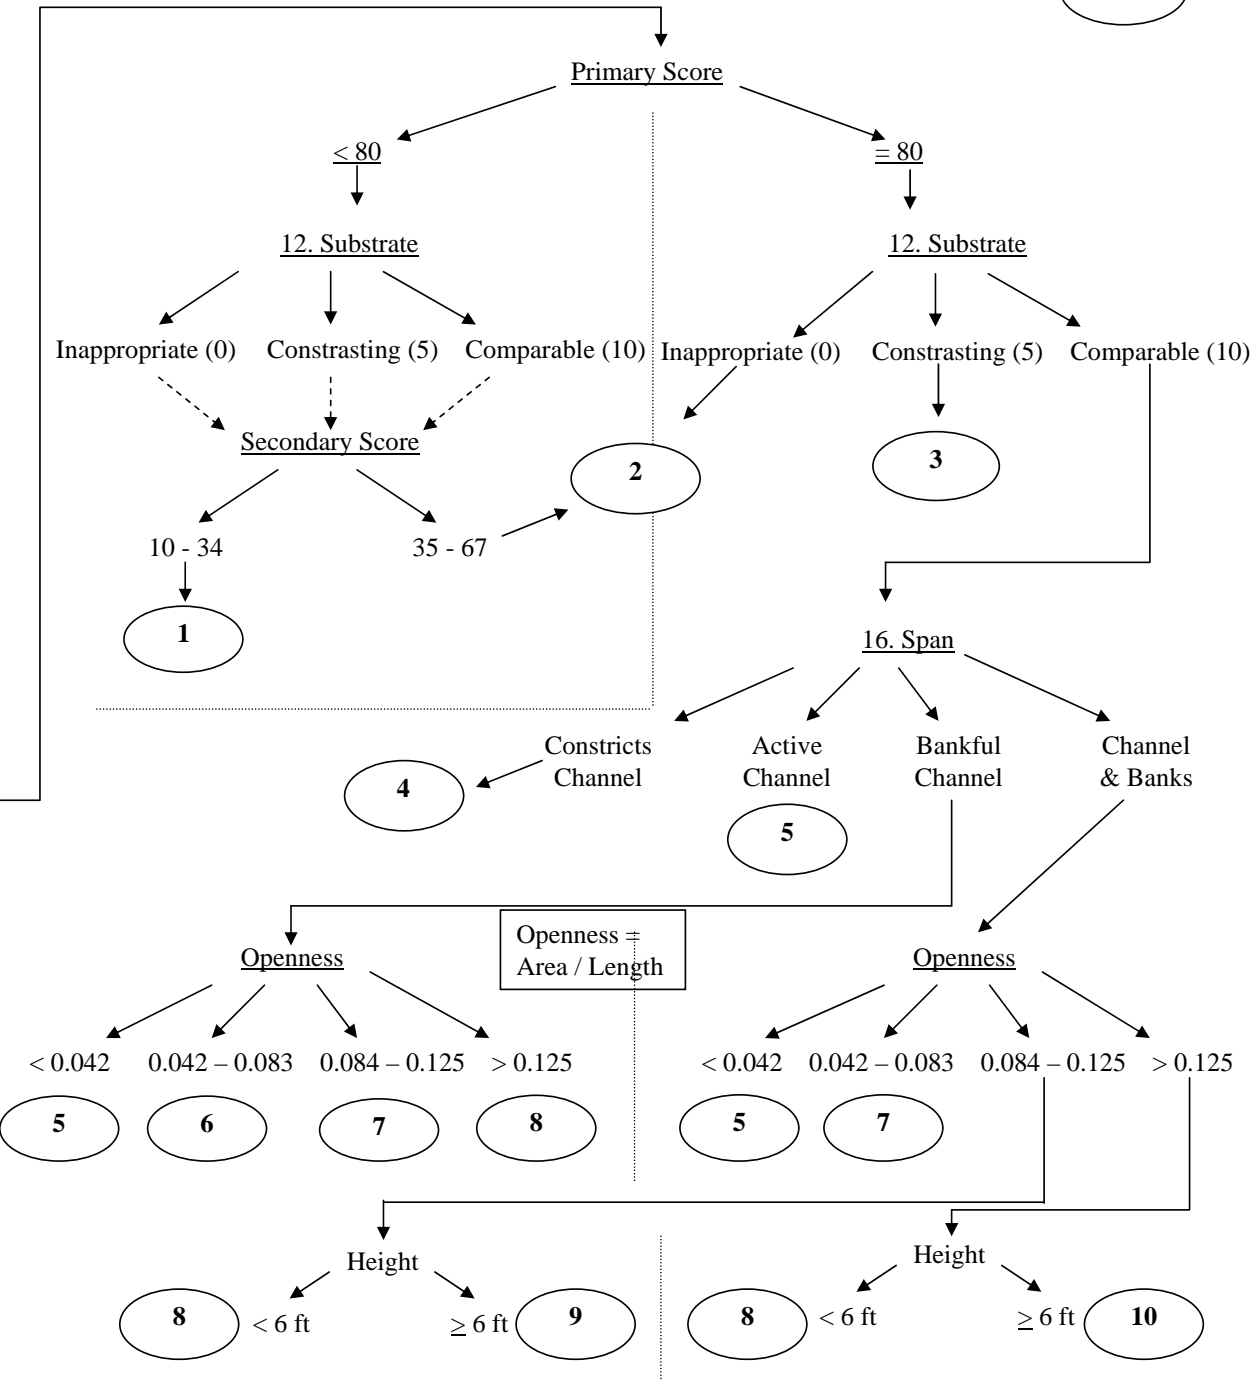
# NH Crossing Structures Scoring System

The key parameters that indicate the extent of fragmentation at each crossing are scored using an algorithm that assigns a preliminary fragmentation score between zero and ten (Appendix 2). The fragmentation scoring algorithm combines multiple parameters and assigns relative fragmentation of a crossing on a scale from zero to ten, zero implying no passage and most fragmenting (Appendix 2). Scores are then translated into four fragmentation classes listed in Table 1.

The algorithm is structured in such a way as to ensure that the most challenging features are prioritized. For example, even if a culvert has all the correct features to allow passage, if there is some sort of permanent barrier, such as a screen at one end, the algorithm automatically scores the site a one (1), or Severe Barrier.
